# GMT 400/900 SERVICE BULLETIN

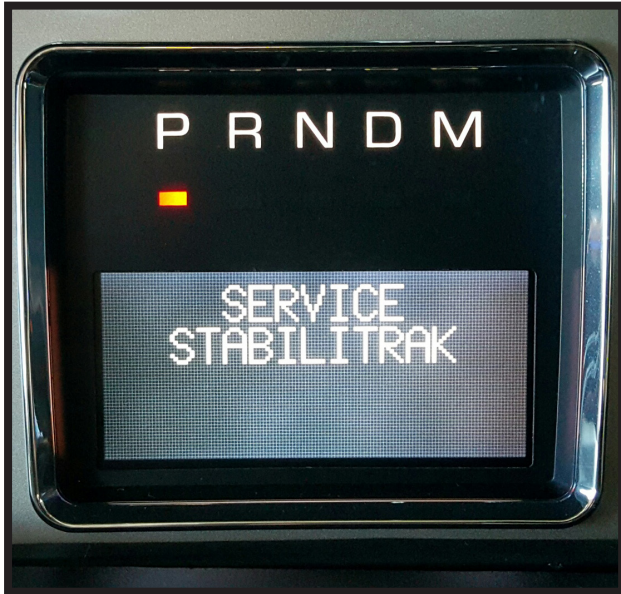
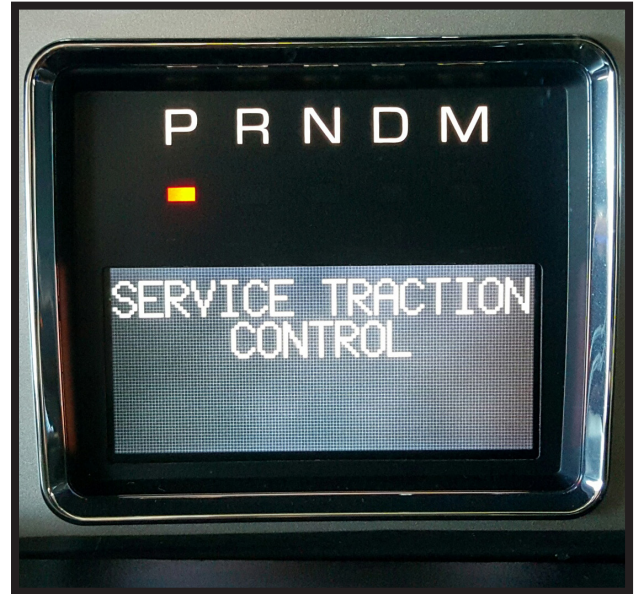
Service Notice

When replacing the rear shocks on these vehicles and accessing the upper shock mounting bolts, there is a high probability that the depicted blue electrical connection for the ABS wiring harness will come unplugged. When faced with this error message after performing a rear shock replacement, check their two connectors, located on each side of the vehicle, on top of the frame rail just behind the upper shock tower. Ensure the connections are good and restart the vehicle.

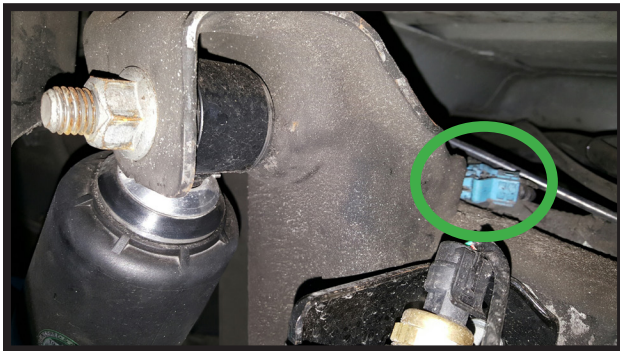
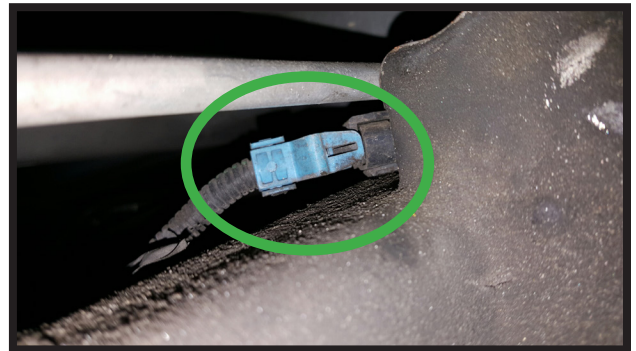
ABS Wiring Harness
